## **Facility Description**

The Town of Crowley wastewater facility is a minor municipal lagoon system. 85 percent of the wastewater flow is attributed to the nearby prison and 15 percent is attributed to the Town of Crowley. The facility consists of three aerated lagoons, a polishing pond, two constructed wetland cells, and a chlorine contact

## **Background Information**

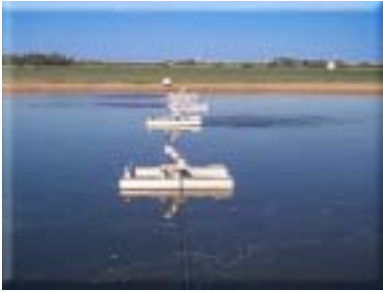
**Aerators on lagoon**

The aerators on the lagoons consume the majority of the energy at this site. The site has a total of 6 – 5hp aerators and 8 – 3hp aerators.

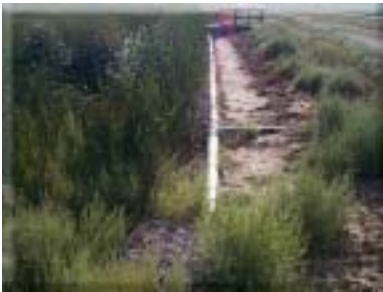
**Influent pipe to wetland**

Pipes in the wetland require frequent 'roto-rooting' to clear-out an unidentified fibrous plant growth.

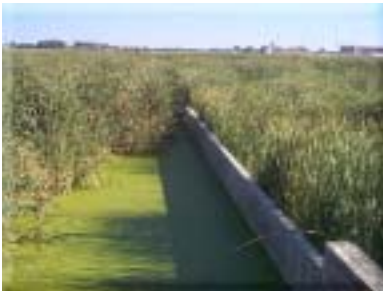
**Wetland cell along barrier**

Perforated irrigation pipe is used to introduce the wastewater into the wetland system. The flow path through the cells is serpentine in order to provide the maximum hydraulic residence time in the system and to minimize short-circuiting. The barrier walls between the wetland cells are constructed of timber. This material poses a problem during burn-off of the wetland cells.

The walls dividing cells in this wetland are wood. When cell vegetation is periodically burned, the wood walls catch on fire, which must be suppressed. If concrete walls were constructed to divide the wetland cells, this concern would be remedied.

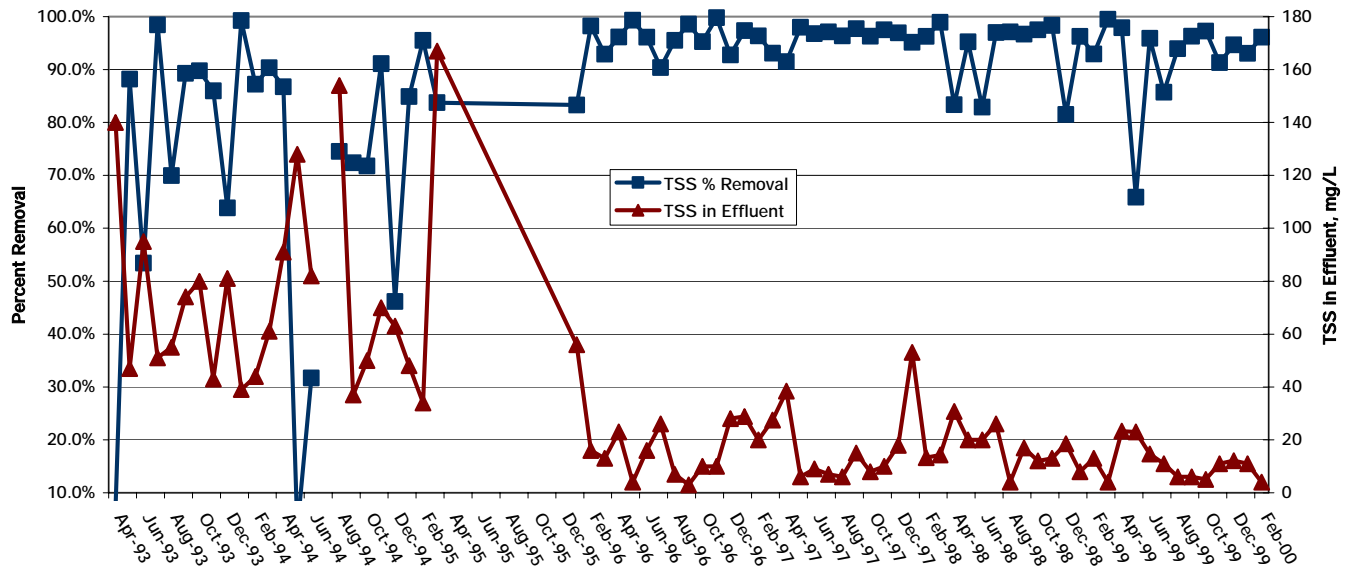
**Town of Crowley TSS Performance**  
Wetlands Completed March 1994

The TSS graph plots the percent removal on the left axis and TSS in mg/l in the effluent on the right axis. Trends in the TSS data indicate that TSS in the effluent has consistently been below permit limitations.

The average daily TSS in the influent, since the wetlands have been operating, has been 489 mg/l. The average TSS in the effluent is recorded to be 29 mg/l. This removal clearly meets the discharge requirements of 75 mg/l.

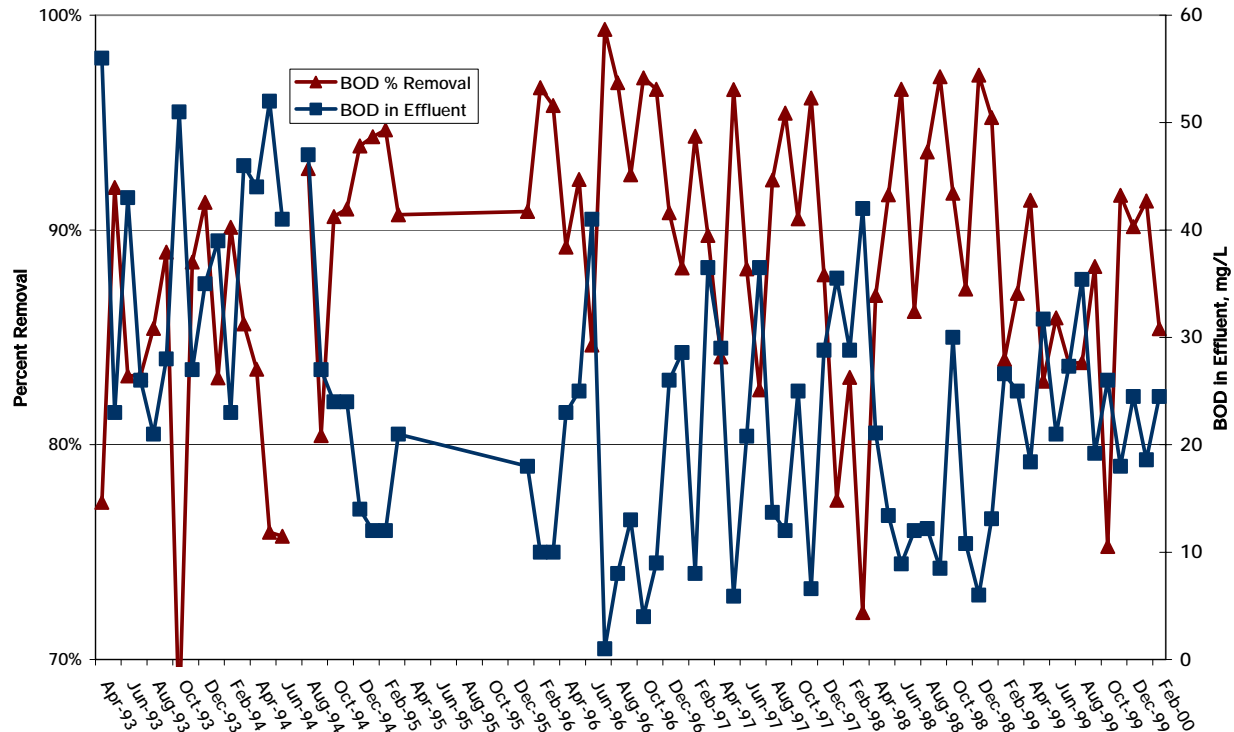
**Town of Crowley BOD Performance**  
Wetland Operational March 1994

The BOD data is plotted similarly to the TSS data, with mg/l in the effluent on the right axis, and percent removal on the left axis. Average monthly influent BOD has been 220 mg/l, the average monthly effluent from the system has been 22 mg/l. This clearly meets discharge requirements of 30 mg/l.

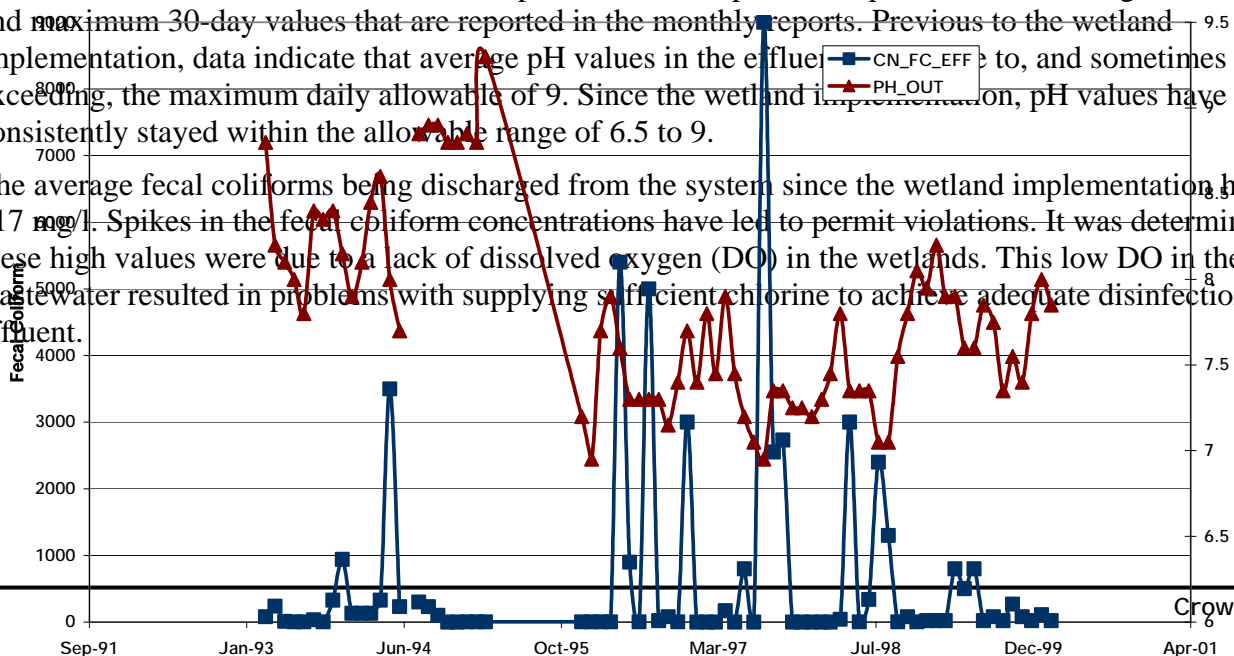
Data for these two categories has been plotted on the same graph. Data reflect the quality of the effluent, no influent measurements are taken for these parameters. The pH values plotted are an average of the minimum and maximum 30-day values that are reported in the monthly reports. Previous to the wetland implementation, data indicate that average pH values in the effluent were around 6.5 to 7.0, and sometimes exceeding the maximum daily allowable of 9. Since the wetland implementation, pH values have consistently stayed within the allowable range of 6.5 to 9.

The average fecal coliforms being discharged from the system since the wetland implementation have been 717 mg/l. Spikes in the fecal coliform concentrations have led to permit violations. It was determined that these high values were due to a lack of dissolved oxygen (DO) in the wetlands. This low DO in the wastewater resulted in problems with supplying sufficient chlorine to achieve adequate disinfection of the effluent.
